## Impact of generator and power grid on unit transformer reliability

**Summary.** Unit transformer is usually connected directly to synchronous generator. Transformer windings are subject to all perturbations, coming from both generator and power grid. The paper lists different types of possible perturbations and presents example of unit transformer failure which occurred in one of thermal power stations.

#### Example of power unit transformer failure

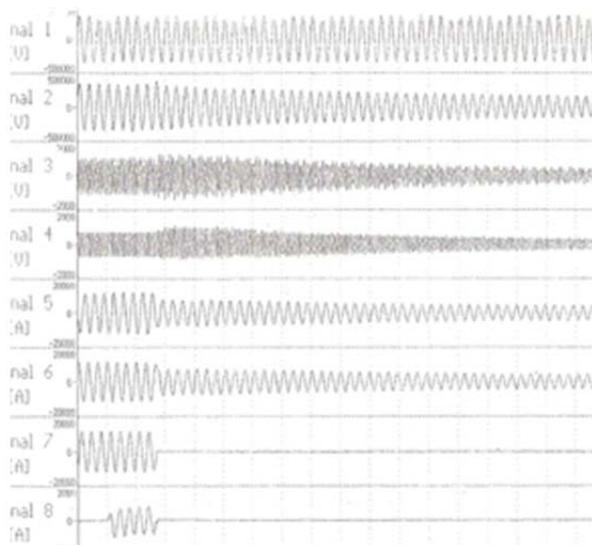
Fig. 3. Voltages and currents - waveforms recorded during failure; different channels are marked as shown in Fig.2

The sequence of events during transformer failure was recorded by disturbance recorder. The committee working on transformer failure was therefore acquainted with record of basic power unit parameters encompassing interval of 0.5 s before the failure, emergency shut-down of power unit and voltage and current decay after transformer shut-down

(see Figs. 2 and 3). Total recording time of the failure is equal to almost 6 seconds. Power unit parameters before shut-down were as follows: grid voltage 245 kV, generator voltage 15444 V frequency 49.760 Hz, generator phase currents 8389 A; 8467 A; 8467 A, active power 209.22 MW. Current appeared in zero-lead of 220 kV winding (see Fig.2), its maximum reached about 570 A, that is c. 0.8 of primary winding rated current value. Zero-lead current could be caused by turn-to-turn short-circuit in one of the phases. The oscillogram shows that after roughly four periods (80 ms), the transformer was disconnected from 220 kV grid by differential protection; simultaneously, the generator was de-excited. Apart from transformer's differential protection, other protective devices were also actuated, among them the Buchholz relay (device) (both sets of contacts). Synchronous generator currents in phase "C" and in zero lead were stopped; currents in phases "A" and "B", while still flowing, decreased steadily until complete de-excitation of generator was reached. This indicated arcing in transformer.

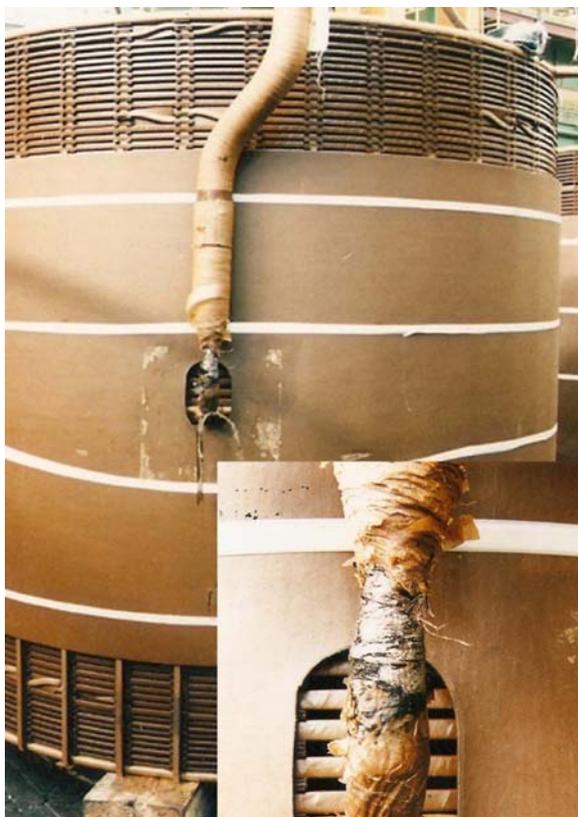
Fig.4. Phase "A" leads

- Deep arc burn of phase "B" winding (45 discs). Burned discs were found in the middle section of the leg, i.e. at the side near phase lead. The terminal was broken.
- The leads of "A" and "0" phases showed charred inner insulation layers (i.e. close to copper wire) and partial overheating of insulation at internal terminals of "0" (neutral) point.
- Insulating (shielding) sleeves of all phases were shattered and displaced at the point of gluing contact.

Damages in GN winding were undoubtedly generated during turn-to-turn short-circuiting in phase "B". However, turn-to-turn short-circuit and short-lasting current in zero-lead could not overheat insulation in this wire. Charring of insulation in zero-lead and "A" phase show that copper temperature reached at least 250°C. During short-circuit this temperature in zero-lead could not be attained. Similarly, overheating of phase "A" terminal could not happen during failure, since short-circuit current flowed through phases "A" and "C" and phase "C" terminal was not overheated. Therefore overheating of insulation in "0" and "A" leads must be due to other, hitherto unexplained reasons. Information on power unit operation obtained from power plant operator does not therefore seem credible, since it does not justify overheating of these wires. Authors may quote from their own experience instances where unreliable information on operation and failure of electrical machines was provided by operators, in particular on occasions when machines' guarantee period had not expired or when failure was due to employees' fault. In this particular case the authors are acquainted with the event occurring on 21<sup>st</sup> Dec., 1996 in nearby plant supplied by the very switch house where transformer in question was connected. Due to sudden rise in voltage different manufacturing devices were damaged (overall costs reaching 48000 DM) together with 100 lamps costing 5000 PLN.

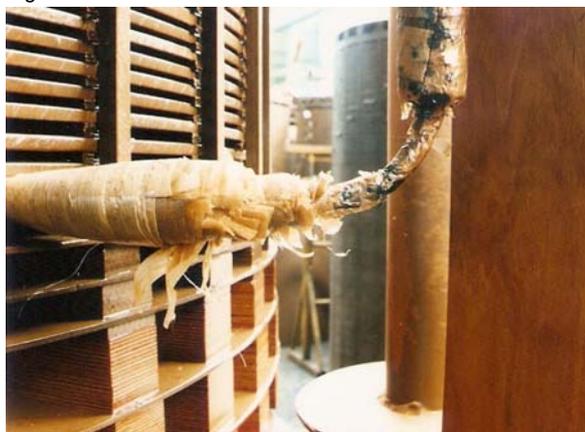
Fig.5. "0" point leads

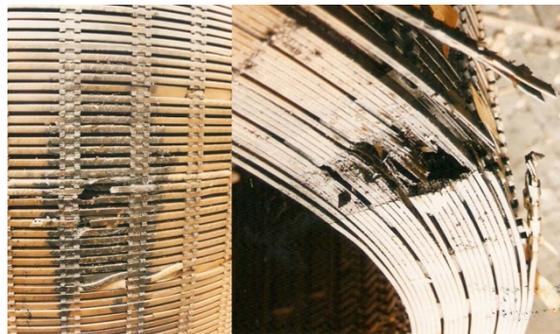
Fig.6. Location of phase "B" winding damage
