doi:10.15199/48.2016.06.32

Fault diagnostics in a traction circuit by means of the stray current analysis

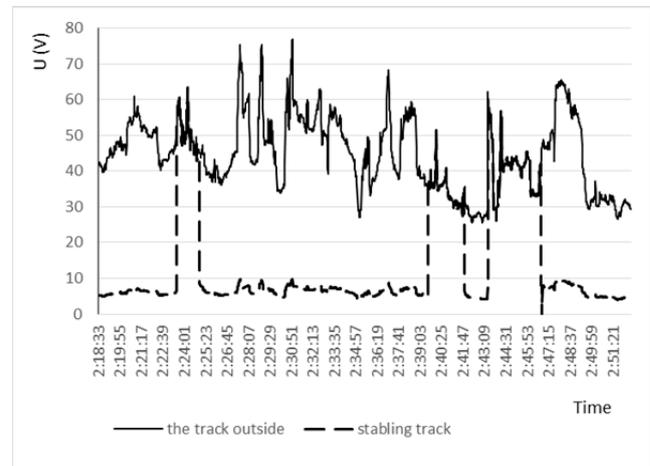
Fig. 2 Example of locomotive passing and short-term conductive connection of an insulated stabling track and an electrified rail. This case was investigated in Bohumin. This graph shows the potential of the measured rail with regard to a distant ground, in relation to time.

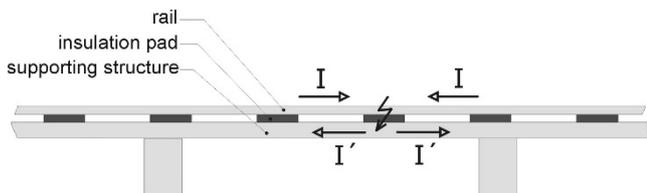
Fig. 2 Current leaking into a steel supporting structure due to a faulty insulation pad

This type of failure (reverse current leaking into a lightning control system) occurred in the technical and hygienic maintenance hall of the Bohumín railway station. Due to damaged insulation pads, a conductive connection was created between rails and their steel supporting structure. As a result, a parasitic current path was formed and current was conducted from the outside track to rails in the hall, the structure of the hall, the lightning protection system and then into the ground. Fig. 4 shows measurement results at a specific time.

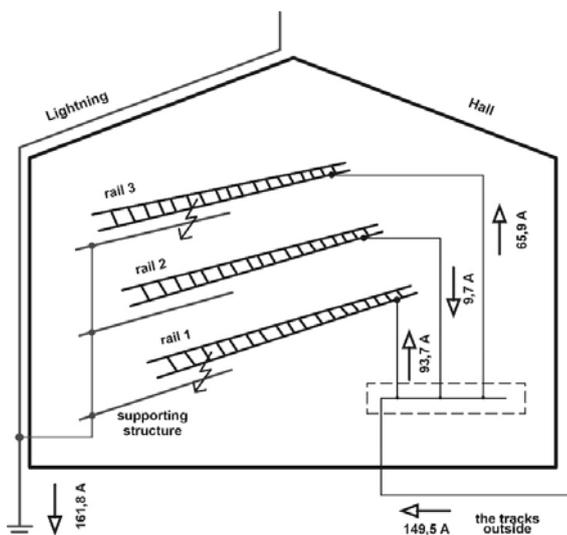
Fig. 4 describes situation in the technical and hygienic maintenance hall at the Bohumín railway station. A parasitic current path was formed, leading from the tracks outside across the hall and the lightning control system into the ground. Measurement results are shown for a specific time. Tracks inside and outside the hall are interconnected with insulation parts, and they are fixed with a copper cable. Track 2 was in use when the measurement was performed.

This situation did not have any influence on the functioning of the traction circuit. The problem was only found out when overheating of lightning arresters in the lightning control system was observed.

Fig. 4 Situation in the technical and hygienic maintenance hall at the Bohumín railway station
