Application of materials science in the investigations of power cable damage

Abstract. The article describes the application of confocal microscopy and Raman spectroscopy in the diagnostics of high-voltage power cables. This issue is presented on the example of a failure that occurred during the start-up of a 110 kV cable line. Positive results of tests conducted by the cable manufacturer and during line acceptance indicated good cable insulation parameters. Material tests excluded the presence of hidden cable defects. In the tested sample, significant erosion of the working core was observed as a result of the impact of the short-circuit current. The depth of erosion allowed for the estimation of the short-circuit current intensity and the time of burning of the electric arc. Based on the above premises, it was determined that the cable was damaged as a result of external interference (sabotage).

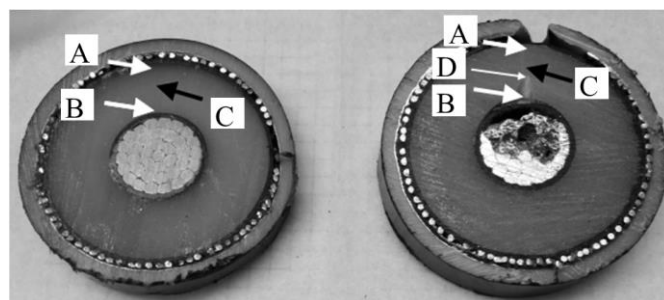
Fig. 1. Investigated sample (right side) with the reference sample (left side). Indications: arrows indicate spots A-D.

During an examination of the exact location of the incident, it was found that the damage occurred above the screen protecting the L1 phase cable. The surface of the cable near the damage site was dirty and had a characteristic dent, which could have been caused by significant pressure or mechanical impact. Microscopic examinations showed that the outer sheath was damaged near the point of damage, exposing the inner layers of the cable. The place where the cable insulation is burned is characteristic of the thermal impact of a short-circuit current, because the channel surfaces are smooth and do not contain metallic deposits. Inspection of the working core of the cable indicates its significant degree of erosion associated with the melting and evaporation of Al during the short circuit. Based on the depth of melting (h), the arc burning time (t) can be estimated using the following relationship:

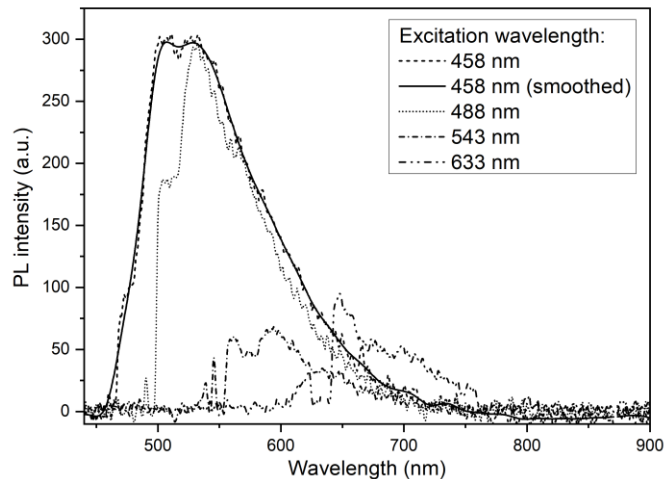
longer excitation wavelengths. The photoluminescence is characterized by wide band with two separated maxima around 505 and 530 nm. In contrast, freshly synthesized polyethylene shows PL spectra of maximum near 425 nm under 375 nm excitation wavelength. However, for the thermally aged polyethylene a strong bathochromic shift of PL spectrum is observed [15]. Therefore, most probably the PL observed in the sample comes from thermally damaged polyethylene.

Fig. 2. The photoluminescence spectra of sample damaged area excited with light beam of varied wavelength.

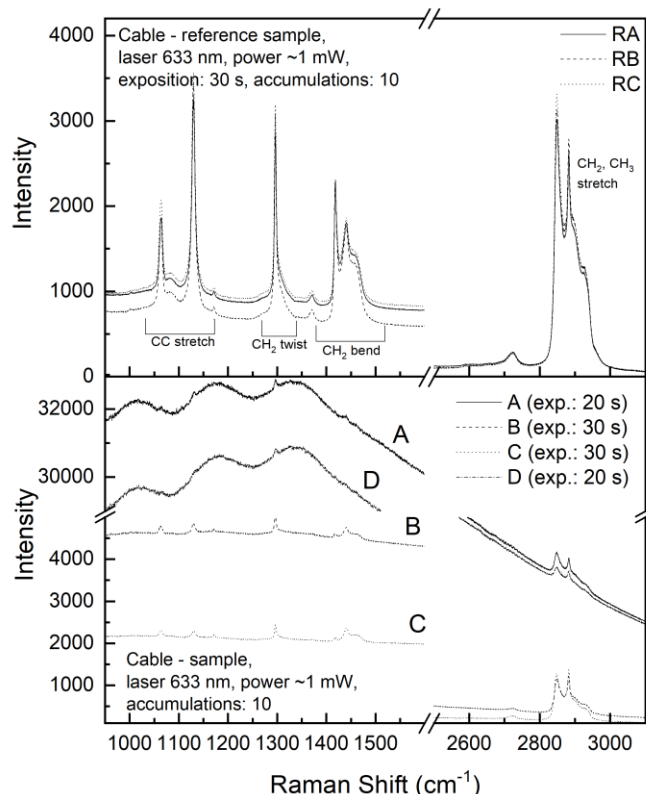
In the Fig. 3A the Raman spectra of reference sample at 3 spots (RA, RB and RC) are presented. The spectra are typical for polyethylene with characteristic bands at about 1063 cm^{-1} , 1130 cm^{-1} , 1296 cm^{-1} , 1418 cm^{-1} , 1441 cm^{-1} , 2849 cm^{-1} , 2882 cm^{-1} [16], [17], and shows that investigated material is rather homogenous without significant differences between the spots.

Fig. 3. The Raman spectra of the reference sample (A) and sample from the damaged part of the investigated cable (B)

Figure 3B shows the spectra recorded from the sample of the damaged cable at indicated points. It is easy to notice, that spectra at the spots A and D are completely different from the reference data. Moreover, a strong background is observed for these spots, which arises from the fluorescence of the sample. However, there is still visible some reminiscence of the polyethylene bands. The spectra at spots B and C are not affected as much as at spot A and D but the differences are still distinct. The obtained results indicate that polyethylene in the sample was decomposed severely at spots A and D. Furthermore, the investigated sample loss some of its crystallinity at spots B and C. The above-mentioned premises shows that the material changes in the damaged area are a consequence of thermal phenomena most probably related to the impact of an electric arc. The spectra measured at points A and D resemble the spectra obtained for polyethylene exposed to temperatures above 150 °C [18]. The changes observed at points B and C also indicate the melting process in the tested sample. Measurements of the reference sample taken far from the damaged location ruled out the occurrence of material defects in the investigated HV cable.
