## Impact of generator and power grid on unit transformer reliability

**Summary.** Unit transformer is usually connected directly to synchronous generator. Transformer windings are subject to all perturbations, coming from both generator and power grid. The paper lists different types of possible perturbations and presents example of unit transformer failure which occurred in one of thermal power stations.

#### Example of power unit transformer failure

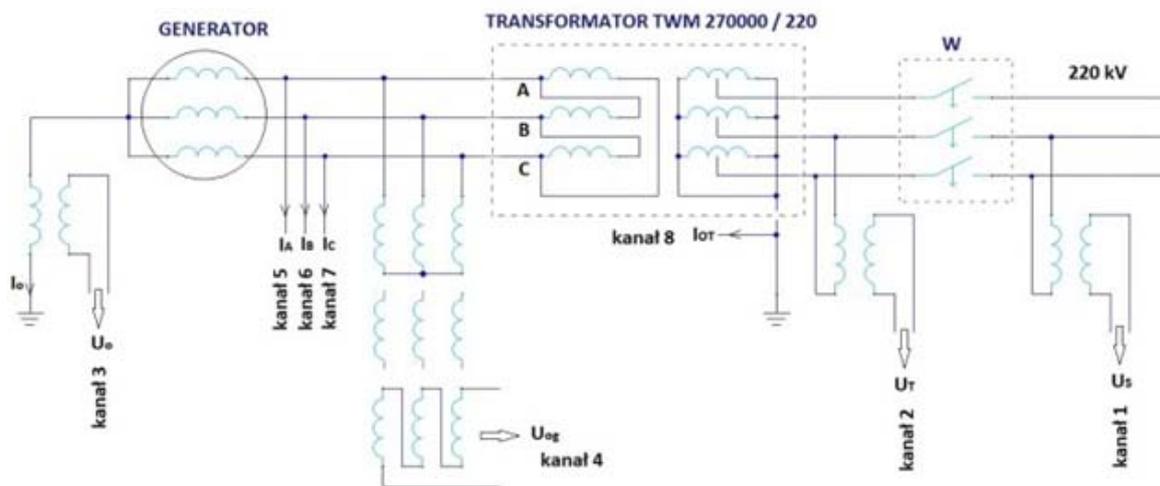
Fig.2. Electrical scheme of power block "generator-transformer" with measurement points marked

(see Figs. 2 and 3). Total recording time of the failure is equal to almost 6 seconds. Power unit parameters before shut-down were as follows: grid voltage 245 kV, generator voltage 15444 V frequency 49.760 Hz, generator phase currents 8389 A; 8467 A; 8467 A, active power 209.22 MW. Current appeared in zero-lead of 220 kV winding (see Fig.2), its maximum reached about 570 A, that is c. 0.8 of primary winding rated current value. Zero-lead current could be caused by turn-to-turn short-circuit in one of the phases. The oscillogram shows that after roughly four periods (80 ms), the transformer was disconnected from 220 kV grid by differential protection; simultaneously, the generator was de-excited. Apart from transformer's differential protection, other protective devices were also actuated, among them the Buchholz relay (device) (both sets of contacts). Synchronous generator currents in phase "C" and in zero lead were stopped; currents in phases "A" and "B", while still flowing, decreased steadily until complete de-excitation of generator was reached. This indicated arcing in transformer.
