doi:10.15199/48.2016.06.32

Fault diagnostics in a traction circuit by means of the stray current analysis

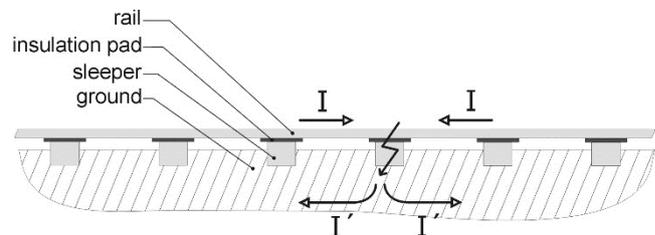
In this case, currents flowing through rails leak into the ground, where they become stray currents.

Fig. 1 Formation of stray currents due to faulty insulation.

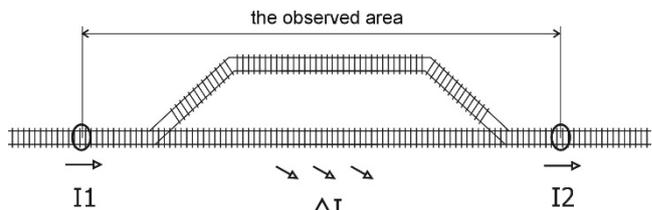
The above described measurement method can be used to find faulty pads as well as to learn more about the extent of the damage and about the size of the leaking current. It can also be used in the assessment of the quality of larger rail units and to learn about the size of leaking current in larger areas.

Fig. 6 More possibilities of the use of the suggested solution

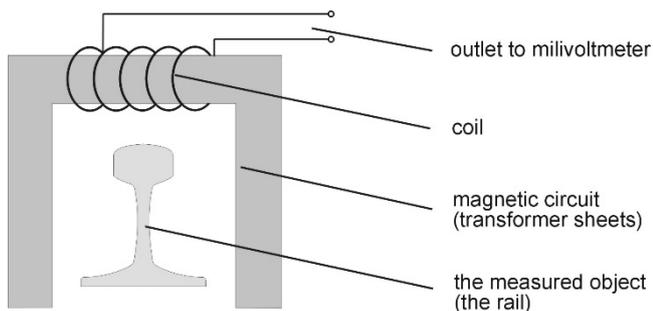
For this reason, a method was designed and implemented to measure current with the use of a modified instrument transformer [3]. The transformer is shown in Fig. 7.

Fig. 7 Schematic diagram of the instrument transformer
