Electrical Performance of Composite Insulator under IEC/TR 62730 Standard Testing for 22 kV Distribution System

Abstract. This research is aimed to test the high voltage (HV) polymeric insulators to study Electrical Performance and deterioration at the insulator's surface under the wheel test conditions. The samples of this research are four new silicone rubber with fiber-reinforced plastic rod insulators, FXB 22/70 model 22 kV that randomized from the commercial market in Thailand. The experiments in this research are the IEC/TR 62730 standards HV polymeric insulators for indoor used tracking wheel test. The results found that the samples' resistance before and after the wheel test of 30,000 cycles has the lower resistance of 10 mm distance on the samples of 37.0 and 7.76 G Ω , respectively. The sample resistances were higher than 2 M Ω resistances, less than 3 mm erosion depth, and no punctured on the shed, housing, or interface that the criteria of the IEC/TR 62730 standards are accepted. Further, the hydrophobicity of the samples before and after the treatment were reduced from HC 1 to HC 6 that classified use STRI's guide. The average leakage currents of the first 10,000 and

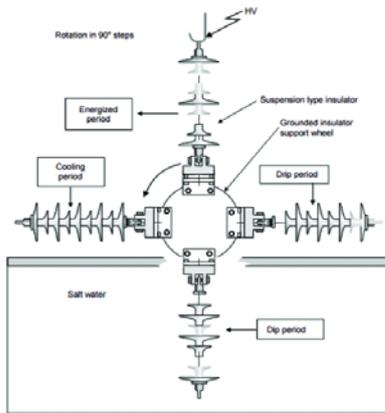
Fig. 2. Tracking wheel test arrangement, IEC standard [3]

The IEC method is based on simultaneous testing of four specimens, mounted on a “wheel”, as shown in Fig. 2. During the test the specimens go in one cycle through four positions, where they remains stationary for approximately 40 s. In the first part of the cycle, the insulator is dipped into a saline solution. The second part of the test cycle permits the excess saline solution to drip off the specimen. In the third part the specimen is connected to a power frequency voltage. In the last part of the cycle the surface of the specimen that has been heated by the arcing discharges is allowed to cool. The main test parameters are listed in Tab. 1. The IEC standard [3] required that the total test voltage will be 28.6 V/mm multiplied by the creepage distance. The creepage distance of the tested composite insulator was estimated as 815 mm.

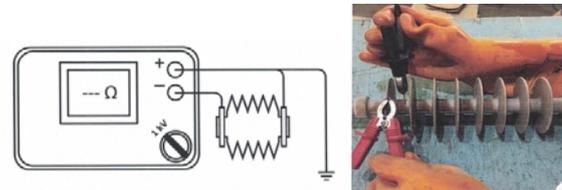
Fig. 4. Testing of surface insulation resistance

The surface insulation resistance was measured under 4 cases; Top, Middle, Bottom and Overall. In each case, the measurement was made between 2 points and follows; Top, Middle and Bottom: Two adjacent points at the top or Middle or Bottom of the insulator, with 5 mm to 10 mm spacing interval. And Overall: The topmost and the bottommost points of the test object, as shown in Fig. 4. At ambient temperature 29.2 °C, Relative humidity 70.1 % and atmospheric pressure 100.858 kPa.

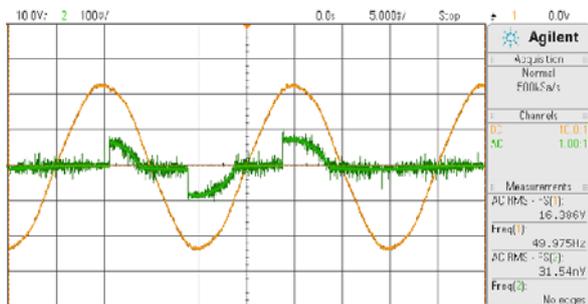
Fig. 8. The waveform of leakage current during partial discharge at 30000 cycles

At 30,000 cycles testing, insulation resistance of composite insulator reduced by 11.69% shown in Tab. 4. It is deterioration in insulation properties and increase in surface conductivity of the insulator cause increasing corona discharge intensity and frequency. Such increase in conductivity is mainly due to accumulated contaminants. When receiving high voltage therefore causing some discharges Resulting in an increased leakage current which results in the heat of the contaminated wet insulation surface in Fig.8.

At 30,000 cycles testing, insulation resistance of composite insulator reduced by 11.69% shown in Tab. 4. It is deterioration in insulation properties and increase in surface conductivity of the insulator cause increasing corona discharge intensity and frequency. Such increase in conductivity is mainly due to accumulated contaminants. When receiving high voltage therefore causing some discharges Resulting in an increased leakage current which results in the heat of the contaminated wet insulation surface in Fig.8.

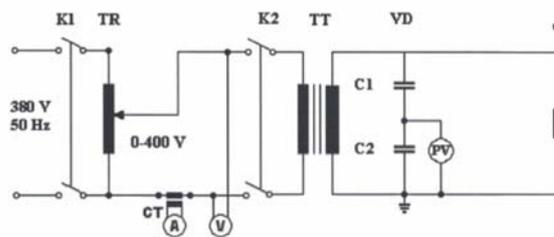
Fig. 9. Power frequency wet flashover voltage test

According to IEC Standard[3]. Fig.9 test circuit consist of K1: Circuit breaker, KM2-F-800 Frame, KM2-T500 Trip unit, TR: Regulating transformer “HIPOTRONICS, INC” 380/0-400V, CT: Current transformer 100T, W/R 365/U core, ratio 500/5 A, A: Ammeter for output regulating transformer “WESTON” type 1944, 5 A, W/0-500 VAC, V: Voltmeter for output regulating transformer “API” type 7045-50Ua, 5A, W/0-500 VAC, K2: Secondary contactor “ASEA” EG 315

size 5, TT: Testing transformer “HIPOTRONICS, INC” model 7300-150,150 kVA, 400V/0-300 kV, VD: Voltage divider, bushing “LAPP” style POC-A, C1 = 382 pF ,C2 = 2146 pF, PV: AC Peak voltmeter “API” type 7045-50Ua, W/0-60/120/320 kV and O: Object under test.

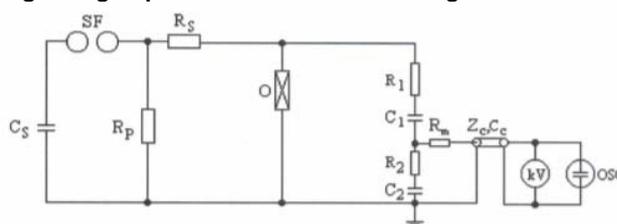
Fig. 10. Lightning Impulse Wet Flashover Voltage Test

Lightning impulse wet flashover voltage test circuit consist CS: Charging capacitor, SF: Spark gap, RP: Parallel resistor, RS: Series resistor, CL: Load capacitor, O: Test object, R1: H.V. arm resistor of voltage divider, C1: H. V. arm capacitor of voltage divider, R2: L.V. arm resistor of voltage divider, C2: L.V. arm capacitor of voltage divider, Rm: Matching resistor 75 Ω, ZC: Measuring cable capacitance 67 pF/m, kV: Impulse peak voltmeter “HAEFELY” Model SV642, OSC: Digitizing recorder “High Volt” Model “HiRES Digital Recorder” in Fig.10. At 100.712 kPa, 30.3°C, atmospheric pressure 100.7 kPa, Humidity 71.0 %, 0.905 inHg, 21.9 g/m³. Calculation of 50 % disruptive discharge voltage V₅₀.

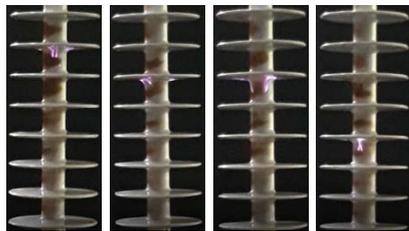
Fig.11. Electrical discharge phenomenon at 30,000 cycles

an increase of leakage current and electric discharge which results in corona discharge and heating of the wet contaminated insulator surface by inequalities due to the mold shown in Fig. 11 and Fig.12. The dielectric loss of the surface layer of silicone rubber under alternating electric field is the main cause of local temperature rise of the composite insulator.

During the application of the test voltage the leakage current causes the evaporation of water on part of the surface. This causes dry band arcing on the surface of the polymer insulators. Frequent occurrence of such electrical discharge causes erosion and tracking of composite insulators. The results showed that the composite insulator would appear abnormal heating under the ageing condition of high temperature, high humidity and salt fog[6],[7].

During the test cycles, the contaminant deposition occurs on the surface of the polymer insulator. This causes
